Friends of Gillfield Wood Final HLF2 Report on Gillfield Wood's Stone Posts

Authors: Kevin Walker and Paul Hancock

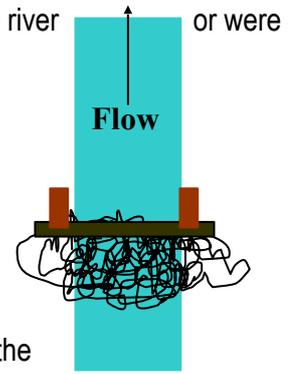
1. Time passed and the barrier became fully silted. As water attacks the weakest point in the structure let's say it veers around post 'B' close to the northern bank of the brook.

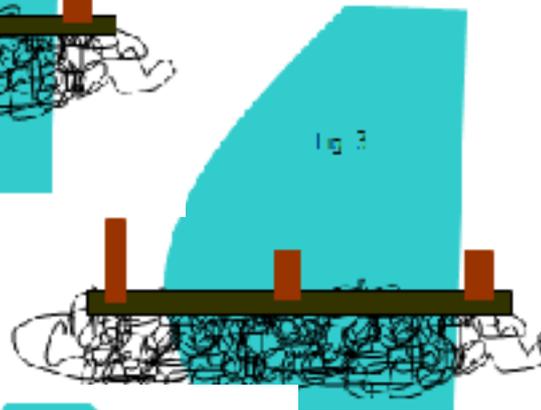
2. Once again after the barrier is reinstated the silting up causes an almost total blockage and the again works at the weakest point structure and cuts around post 'C' south bank.

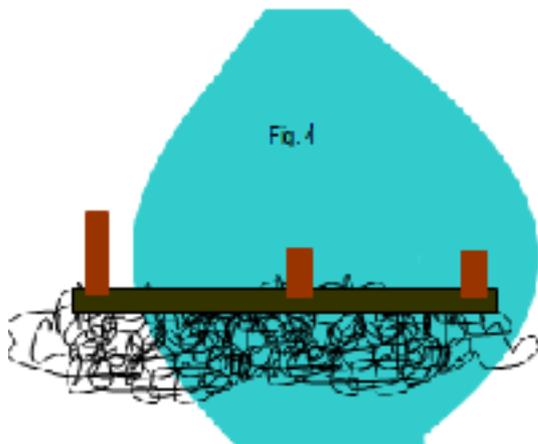
3. The barriers purpose of either blocking or filtering the water flow is once again compromised with high amounts of silt deposited in front of and around the barriers although over time the southern bank would be gradually eroded away.

- Once again it can be argued that the profile of the silt upstream increases from brook bed level up to 750mm deep around post 'A' and diminishes back to brook level downstream. Photographs PH600/3/A/33 and 43.

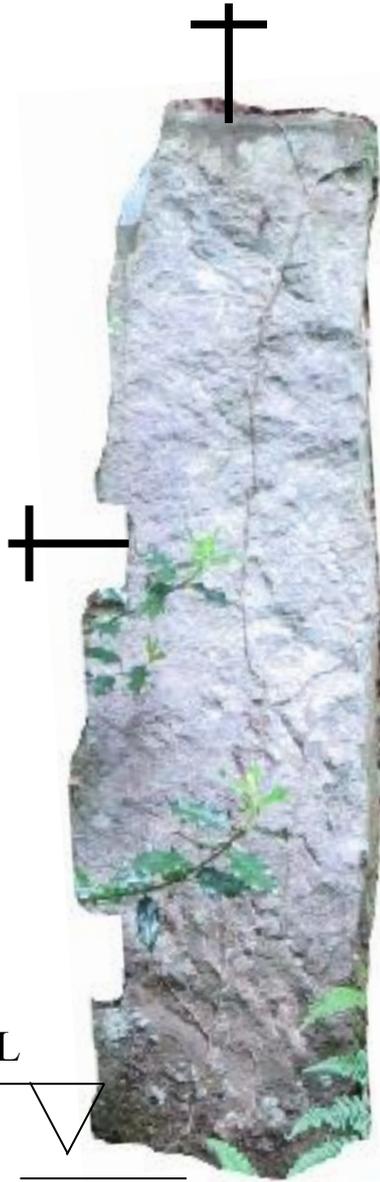
Post A

STANDING
BUT AT RISK

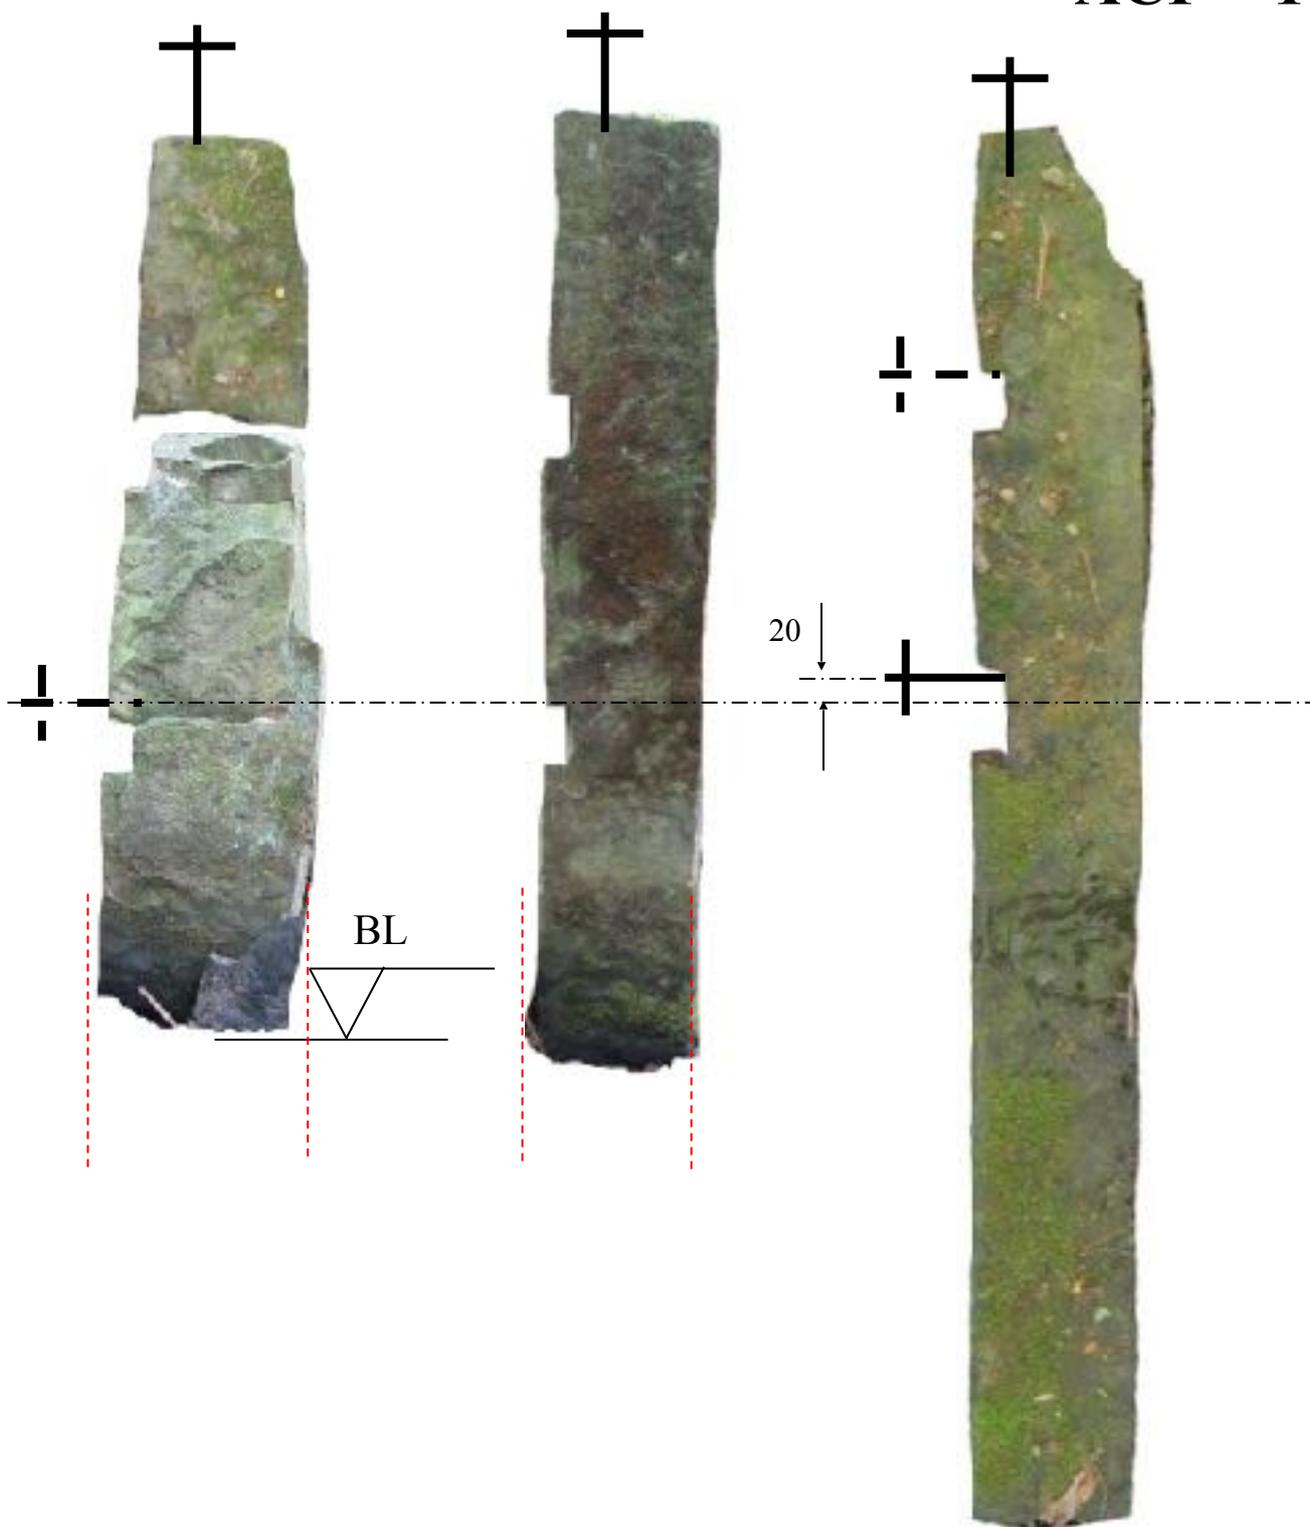
Post A

STANDING (TOP IN BROOK)
